Service Log AN/GRC-109
PP2685 PSU recapping and misc,
18-Nov-2023, Virgil Cheng vr2xgm

PP2685 recapping and AC meter replacement, 17-Nov-2023

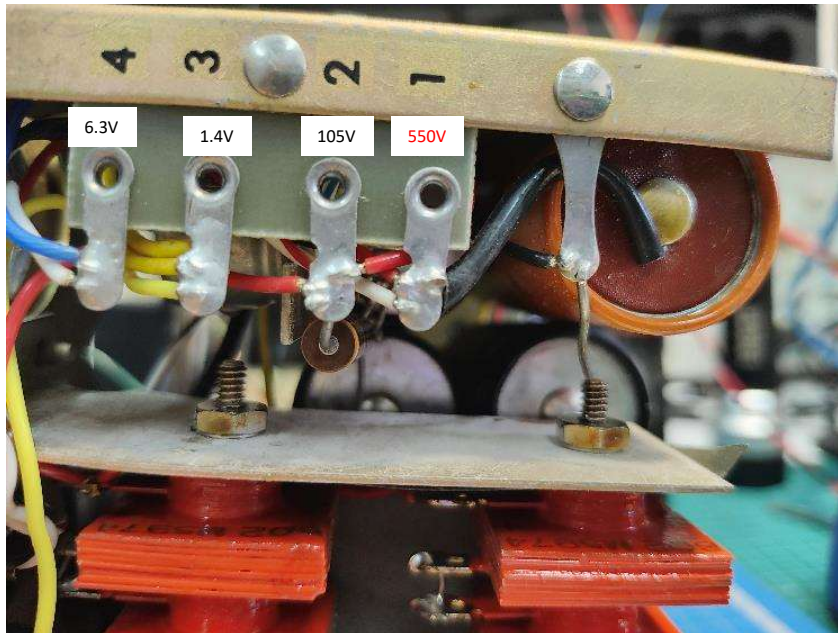
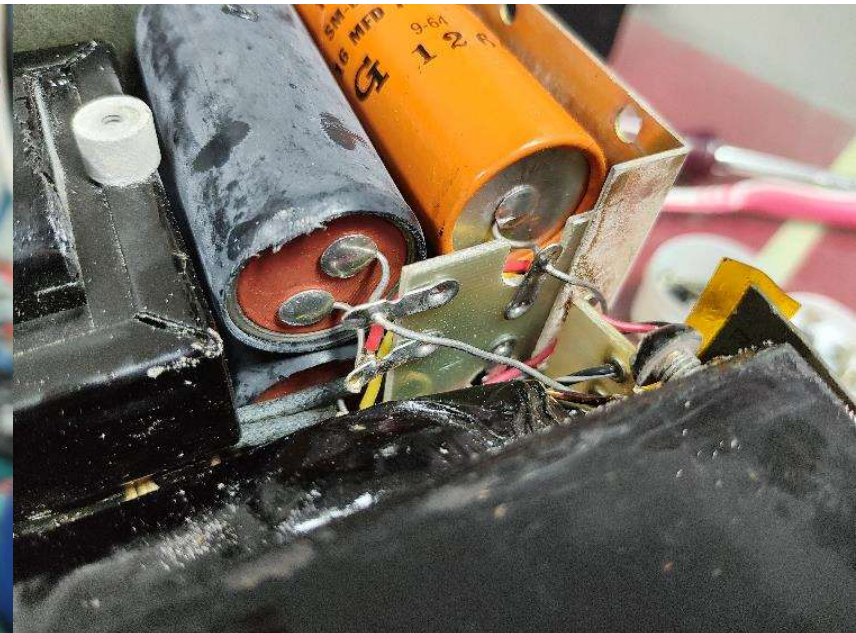
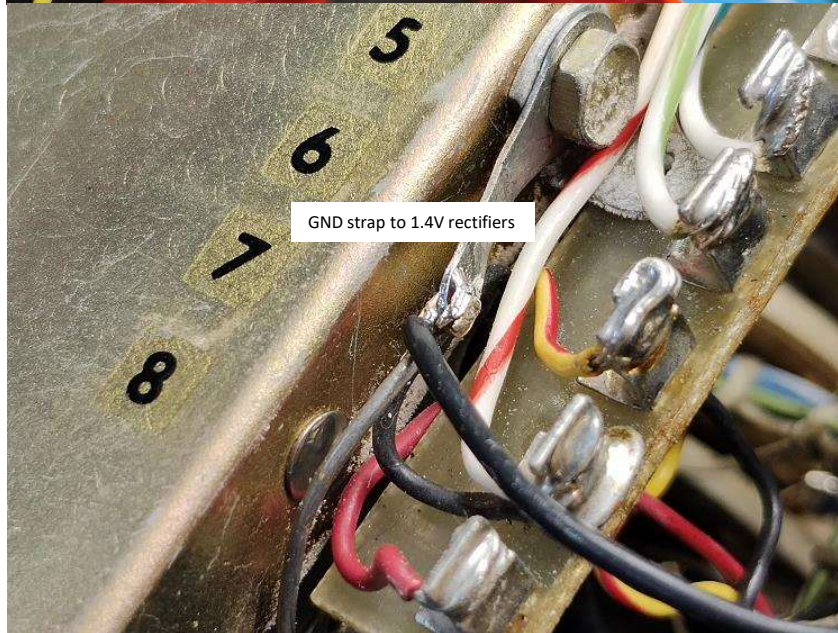
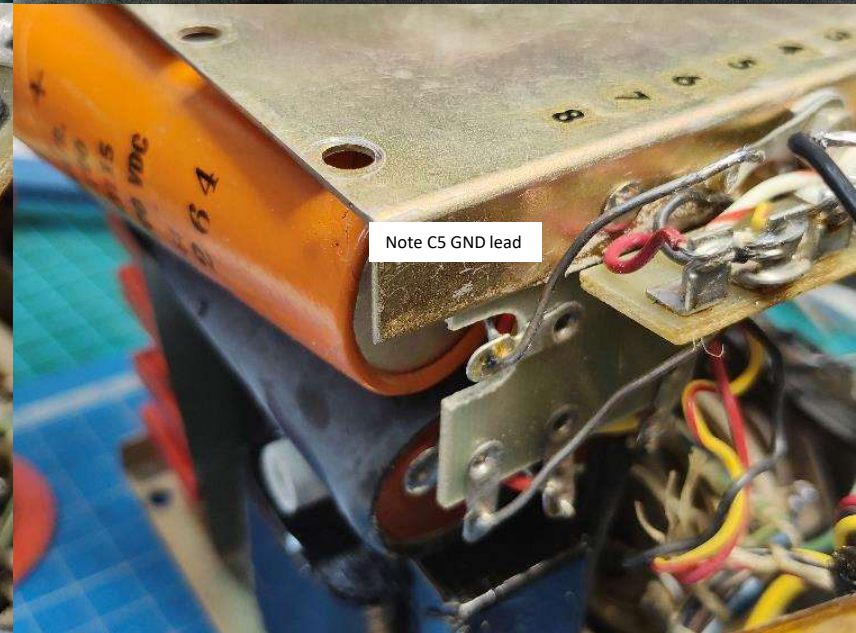
Original capacitor locations

- Unit operational, Oct-2023 opened for routine inspection after receiver tube failure
- Capacitor leaking, 16uF 700V date code 1264, 20uF x 2 450V date code 1264, 2000uF 6V 2pcs date code 1264
- Chassis metal surface stained by evaporated electrolyte, cleaned with Alcohol

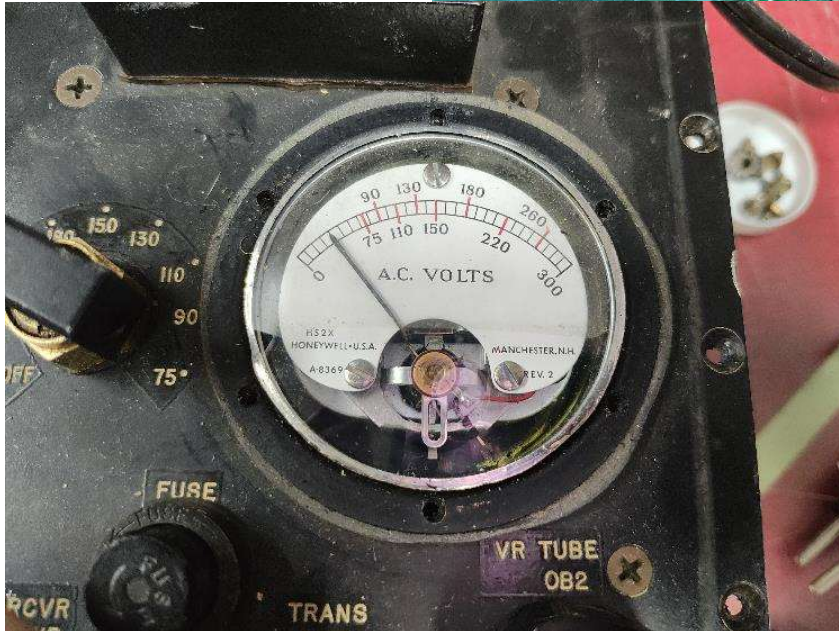
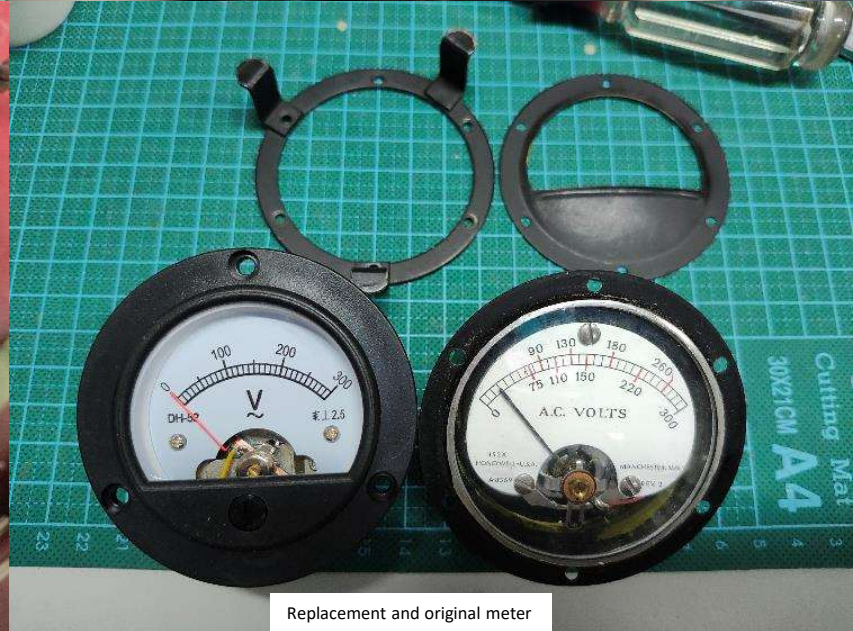
Replacement and original meter

- original meter or similar unable to find
 - Found China made DH-52 series, plastic housing, not waterproof, 52mm diameter, mounting hole similar
 - mounting holes need modification, additional three holes to be drilled

- deeper than original, still able to fit with sufficient safety clearance
- Modification- add two series Silicon rectifiers to filament output, improve no-load voltage to 1.6V (was ~2.5V)

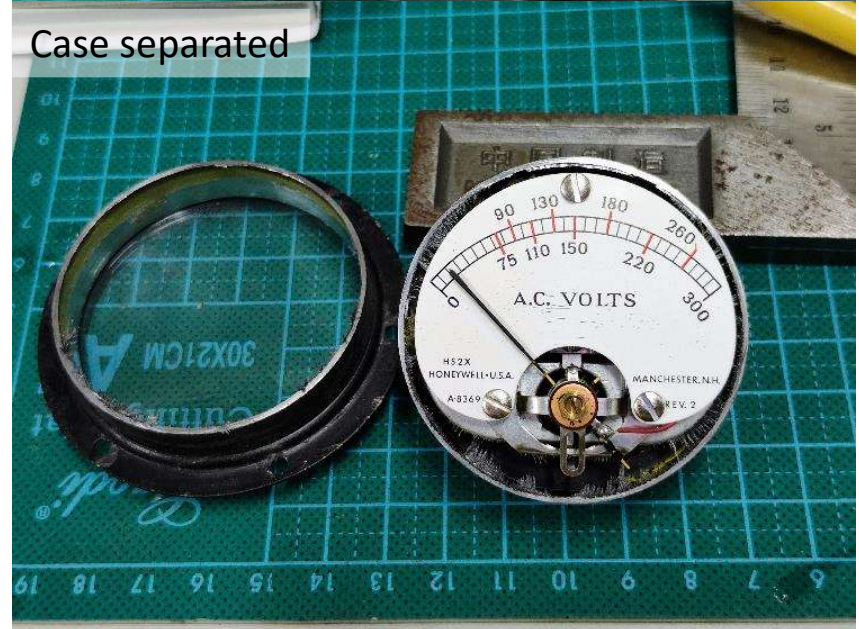
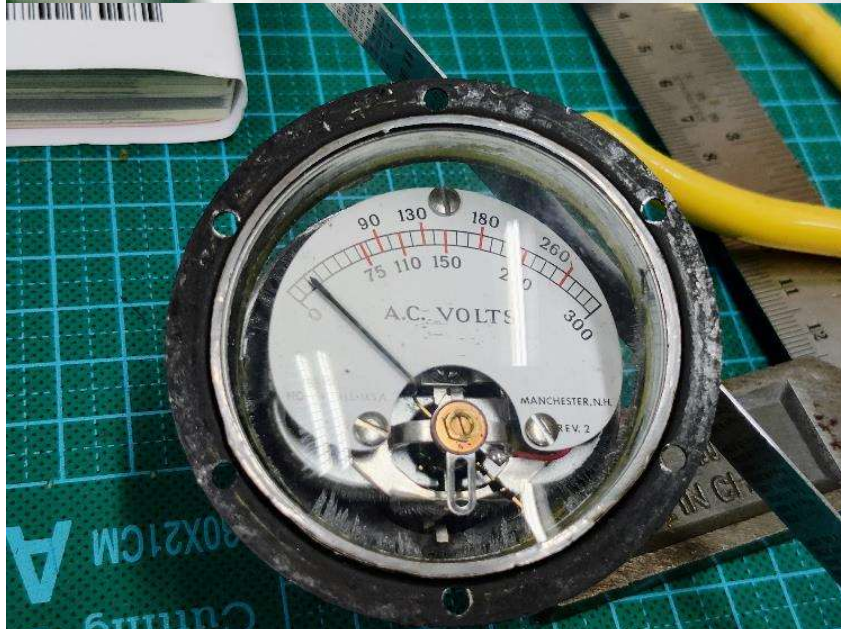
Case separated

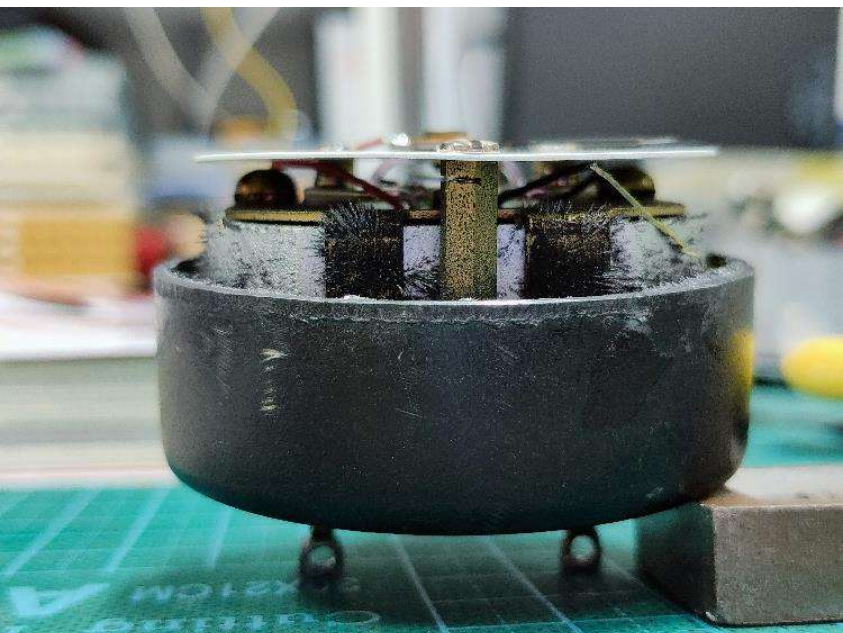
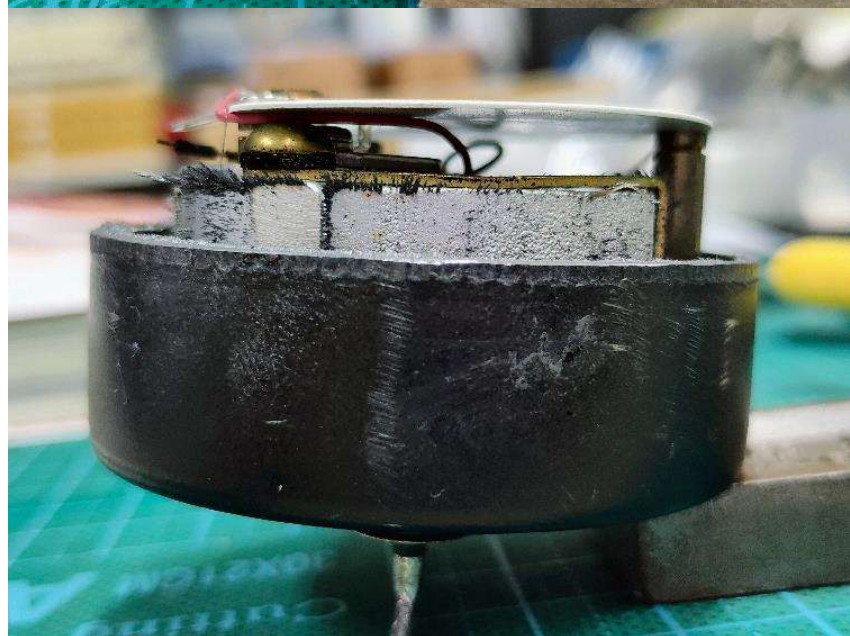
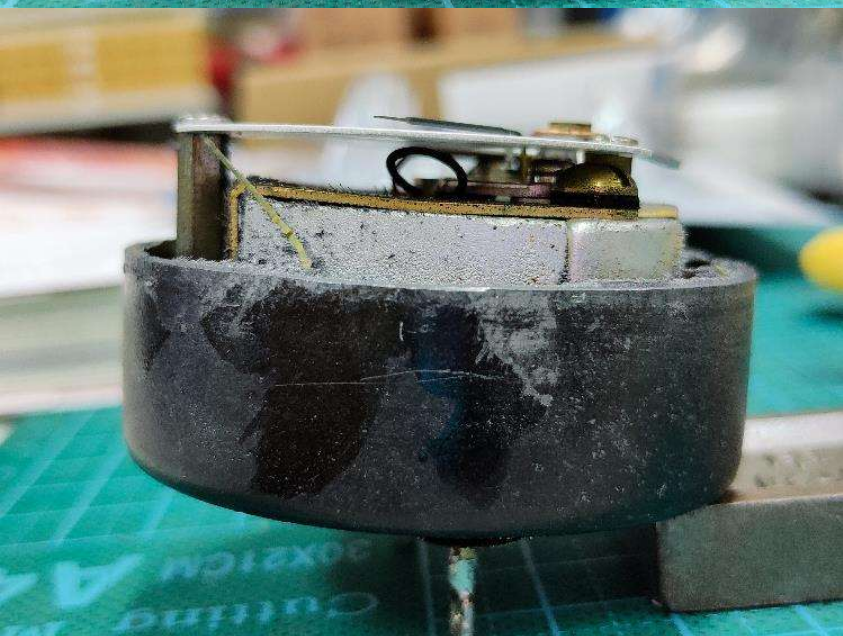
Iron filing is problematic, especially those fell between moving coil and magnet, I used small adhesive tape strips for cleaning
